Contract #: 04-0120F4Cty: SF/ALA Rte: 80 PM: 13.2/13.9File #: 69.28**WELDING INSPECTION REPORT****Resident Engineer:** Pursell, Gary**Address:** 333 Burma Road**City:** Oakland, CA 94607**Report No:** WIR-016275**Date Inspected:** 01-Aug-2010**Project Name:** SAS Superstructure**OSM Arrival Time:** 700**Prime Contractor:** American Bridge/Fluor Enterprises, a JV**OSM Departure Time:** 1900**Contractor:** Zhenhua Port Machinery Company, Ltd (ZPMC), Changxing Island **Location:** Shanghai, China**CWI Name:** Guo Yan Fei, Chen Shi Gang**CWI Present:** Yes No**Inspected CWI report:** Yes No N/A**Rod Oven in Use:** Yes No N/A**Electrode to specification:** Yes No N/A**Weld Procedures Followed:** Yes No N/A**Qualified Welders:** Yes No N/A**Verified Joint Fit-up:** Yes No N/A**Approved Drawings:** Yes No N/A**Approved WPS:** Yes No N/A**Delayed / Cancelled:** Yes No N/A**Bridge No:** 34-0006**Component:** OBG**Summary of Items Observed:**

BAY 04, DECK PANEL REPAIR**13BW-DP3136-001**

WELDING INSPECTION REPORT

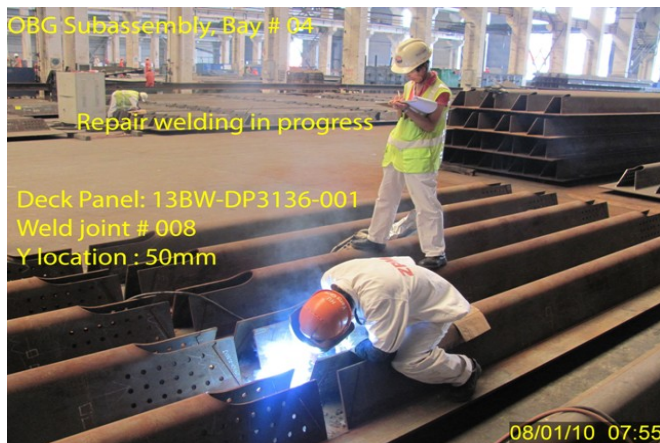
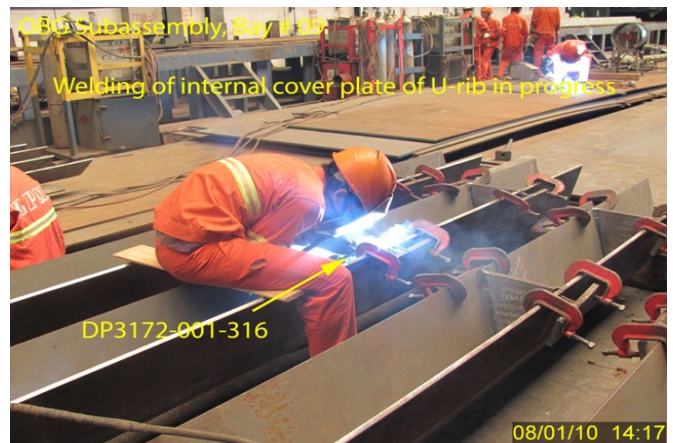
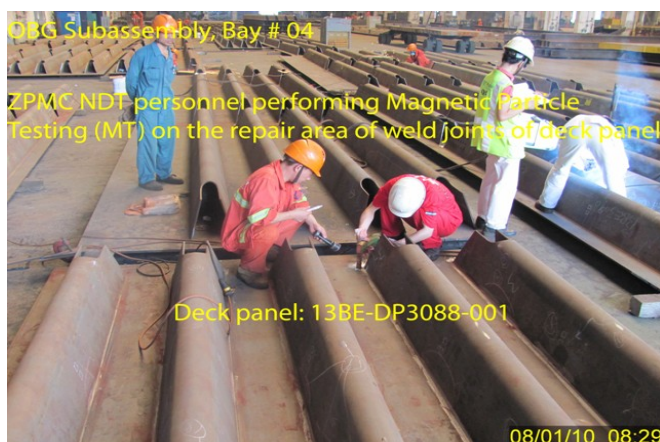
During random in process inspection this QA inspector observed that ZPMC personnel were performing repair welding on the Partial Joint Penetration (PJP) weld joints of deck panel 13BW-DP3136-001. Welder is identified as 203805. ZPMC CWI is identified as Mr. Guo Yan Fei. The welding variables recorded by QC appeared to comply with WPS-345-FCAW-2G(2F)-FCM-Repair. The repair area details are as follows.

During random in process inspection this QA inspector observed that ZPMC personnel were performing repair welding on the Partial Joint Penetration (PJP) weld joints of deck panel 13BE-DP3090-001. Welder is identified as 062265. ZPMC QC is identified as Mr. Zhang Hai Tao. The welding variables recorded by QC appeared to comply with WPS-345-FCAW-2G(2F)-FCM-Repair. The repair area details are as follows.

This QA inspector observed that ZPMC NDT personnel was performing Magnetic Particle Testing (MT) on the repair locations of weld joint of deck panel 13BE-DP3088-001.

FCAW welding of weld joint 316 located on DP3172-001.

Unless otherwise noted, all work observed on this date appeared to generally comply with applicable contract documents.
